# SELAH CITY COUNCIL

- Jeff Peters a. Acceptance of 102 East Naches Ave. Property Evaluation Report (Wells Fargo) prepared by HLA Engineering and Land Surveying & BORArchitecture

# Property Evaluation Report

**102 East Naches Avenue  
Selah, Washington, 98942**

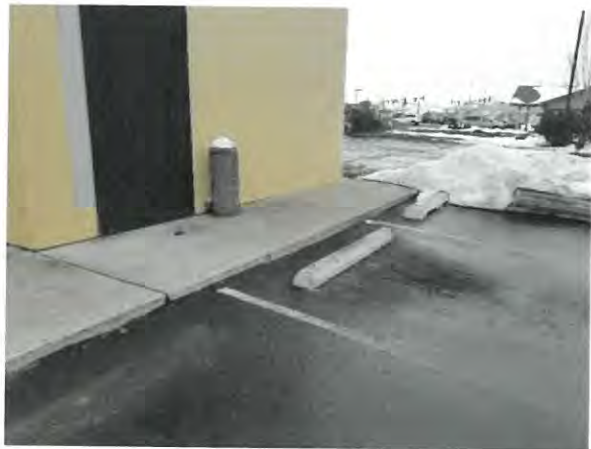
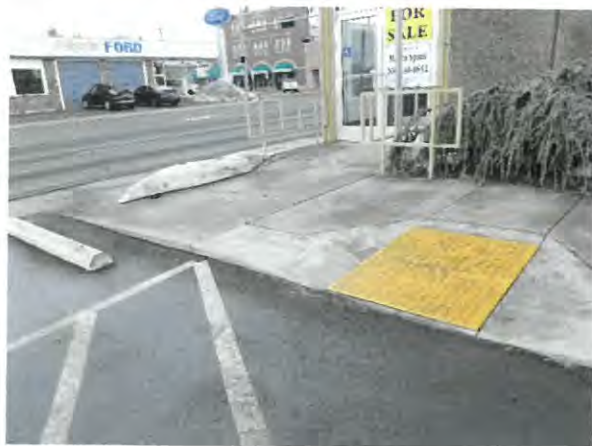
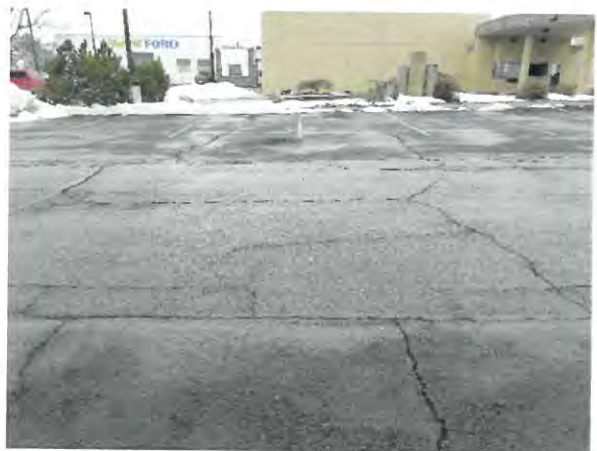
The property is sloping gently to the southwest. The site has asphalt paved drive aisles that extend thru the existing parking lots and bank drive-thru area. The existing parking areas are comprised of the main parking lot located south of the existing building, and the additional parking lot located to the east of the drive-thru area. Snow covered a portion of the parking lot, so the exact number of parking stalls was unable to be verified. Previous reports indicate there are 32 parking spaces, but in review of aerials, only 30 parking spaces were identified. There are two ADA-accessible parking stalls, one of which has been designated for vans. The sidewalk servicing the ADA parking does not appear to meet ADA slope requirements, and would need to be revised.

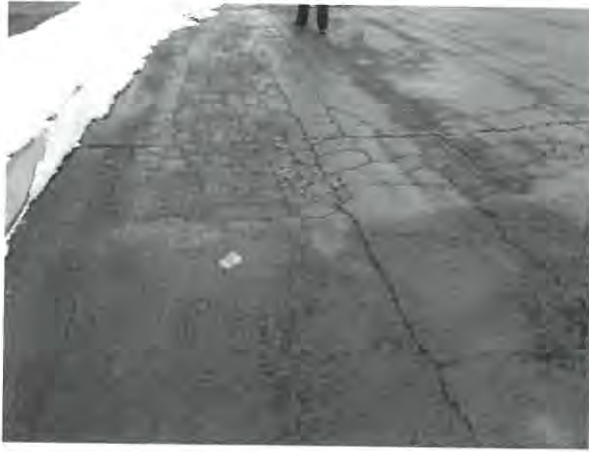
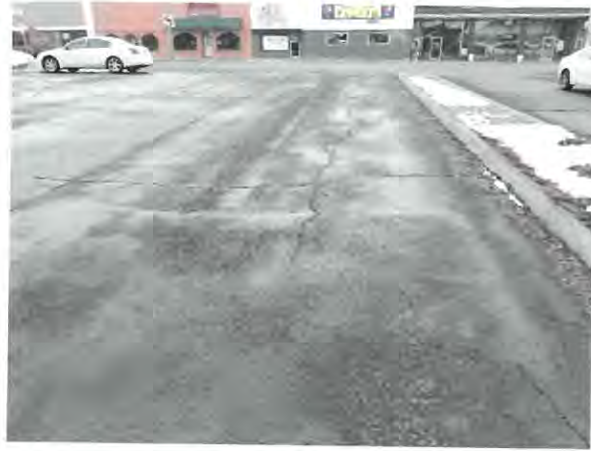
There are two entrances to the property; one into the east parking lot along East Naches Avenue, and one into the main parking lot along South 1st Street. The concrete aprons appear to be in good condition. The entries have no significant deficiencies and entrance widths appear to be adequate.

Cast-in-place concrete curbing is located along the parking lot pavement perimeter. The height of the concrete curbing appears to vary significantly with some less than standard curb height, and some taller than standard curb height. There are also some areas with cracks and chunks missing from the curbing. Although not ideal, the curbing appears to be mostly functional and does not need significant repair.

The asphalt paving in the main south parking area is generally in fair condition. The asphalt paving in the east parking lot has severe alligator cracking and has essentially reached the end of its useful life. The asphalt does not need to be replaced immediately, but it will continue to deteriorate until it comes apart. At a minimum, the parking lot needs a fresh application of sealants and the parking markings need restriped.

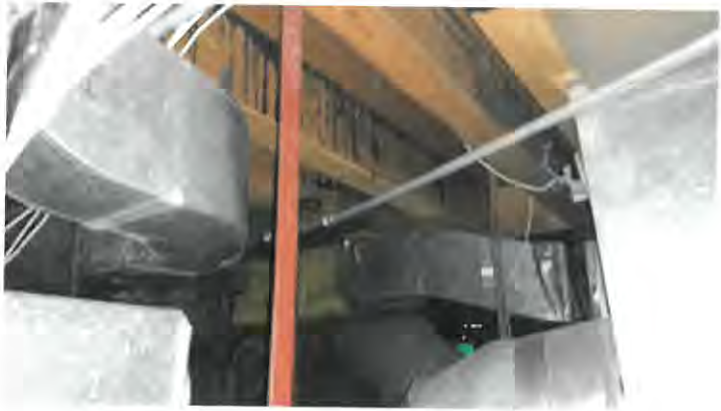
The roof system appears to span the full width of the building from east to west. It is possible that the second floor west wall could also be a bearing wall supporting the roof system, but this load would transfer to the floor joist support beam. Given there is only one support column for this beam, it seems unlikely that the beam carries the loading. The roof framing system also appears to be somewhat unconventional. The framing is possibly a panelized roof system rather than a roof joist with plywood sheathing. The framing appears to have a partial joist with a 2x vertical member and a 1x bottom member with no top member to the joist. The roof sheathing is glued and nailed directly to the joist, acting as the top member. The structural systems appear to be in good working condition, and well maintained from a structural perspective. The roof does appear to have started to leak, especially in the drive-thru teller bump-out area. At this time, it does not appear the minor leaking has caused any structural damage.

It should be noted the modifications to the panelized roof system would be difficult since the system design was proprietary, and the structural properties are difficult to model. This might limit the ability to change the roof mounted HVAC systems, unless it can be shown the new units are lighter than the existing units.

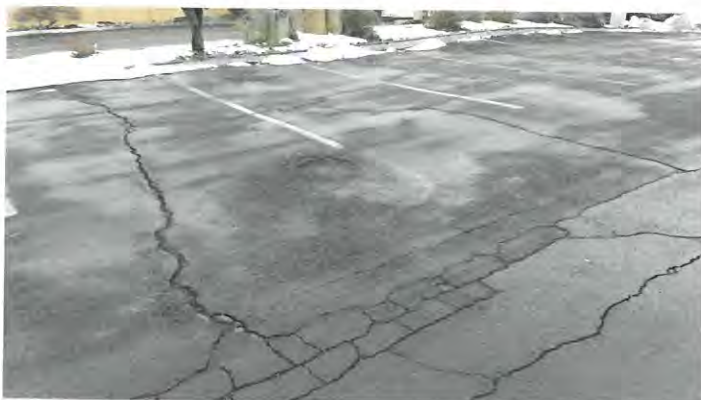
Alligator cracking in parking lot

The east parking lot will need to be repaved, and it would make sense to repave the south parking lot at the same time, so the entire parking lot is on the same paving schedule. At the time the parking lot is repaved, we recommend the stormwater system be revised to infiltrate stormwater on site, and eliminate the connection to the City of Selah municipal stormwater system.

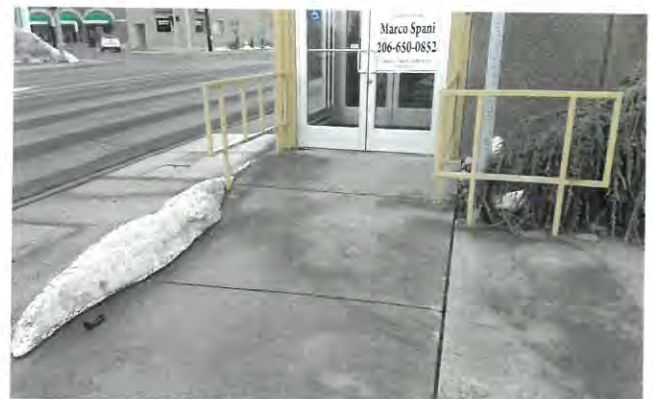
At the south entry the slope of the sidewalk as it intersects the public sidewalk is too steep. It does not meet accessibility standards for slope or landings and needs to be repaired.

Steep slope at south entry

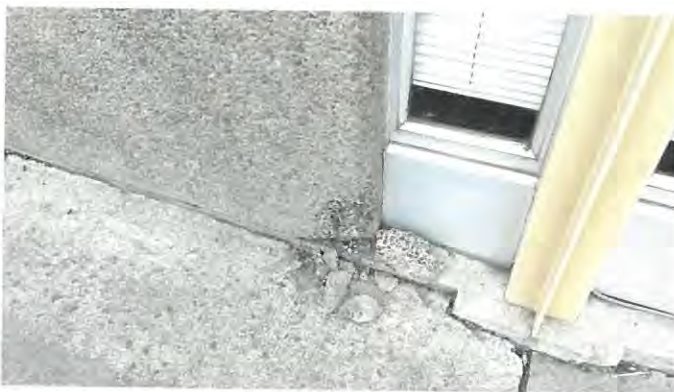
Cracked and spalled corner of precast panel

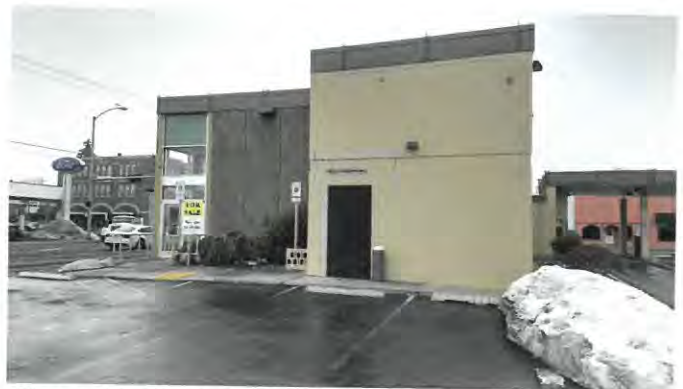
There is a large hole in the south wall of the building where the bank's ATM had been located. The hole is covered by a painted plywood panel. This temporary repair is working for the present, but the hole should be filled in with CMU and EIFS to match the wall area around it.

Plywood infill at former ATM location

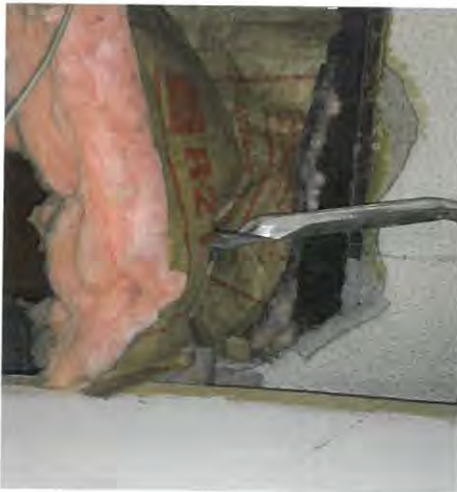
Water damage from roof leak at teller window

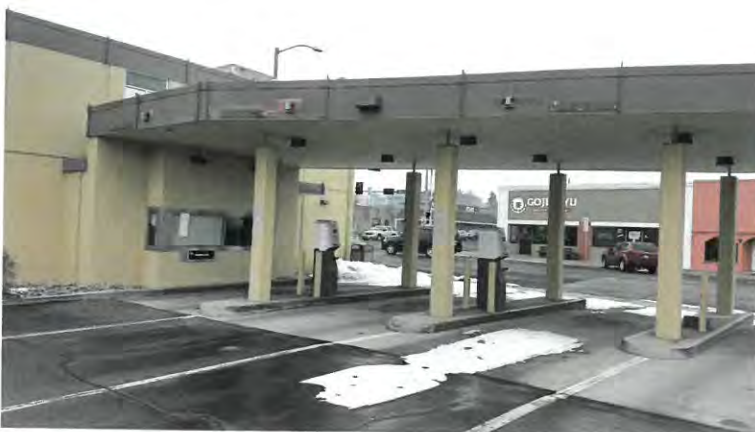
Several of the metal fascia panels on the drive-thru canopy have holes, discoloration, and are warped or oil-canning where signage and lighting were removed. The holes should be patched before damage from water intrusion can occur.

Fascia on drive-thru canopy

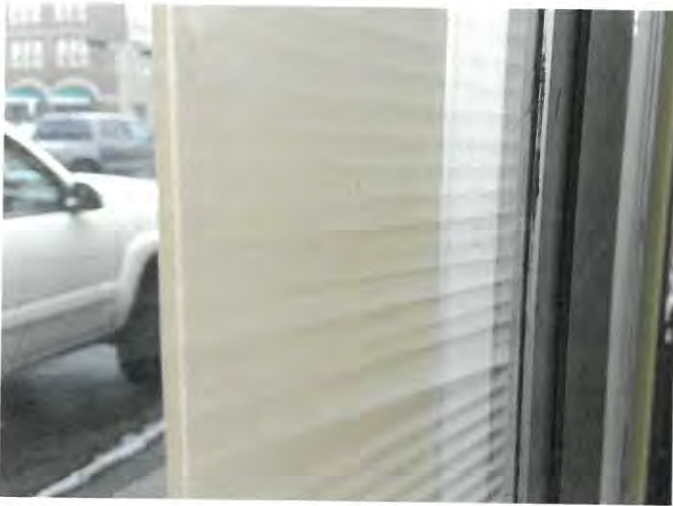
Exterior windows, single pane glazing

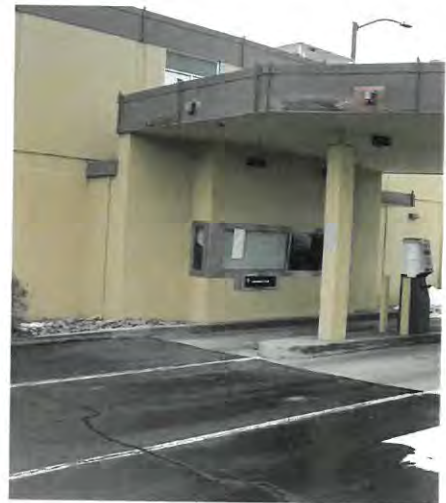
Teller window and drawer

The existing teller window and drawer will likely need to be removed and infilled or replaced with an aluminum storefront window to match the existing (or other new windows).

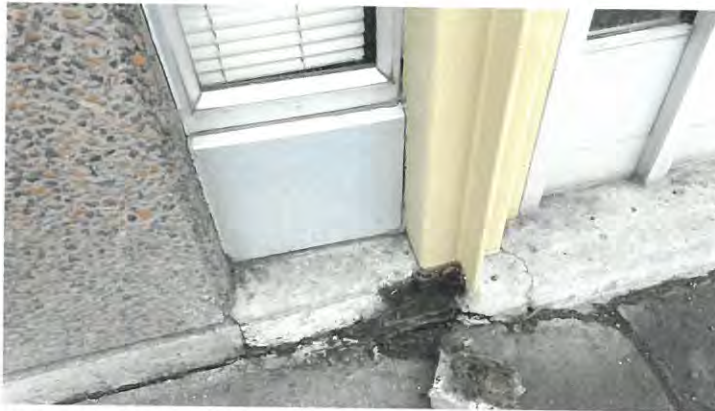
Along most of the north and south exterior walls and along the length of the west wall the steel structural columns are exposed as part of the design of the building. In many locations around the bottom of the columns the paint is chipped and rust has formed. It is recommended that these areas be thoroughly cleaned and rust removed by wire brush. A rust inhibitor should then be applied and the areas primed and painted with appropriate exterior paint. Cracked or broken concrete should also be repaired.

Rust at bottom of steel column and spalled portion of concrete base

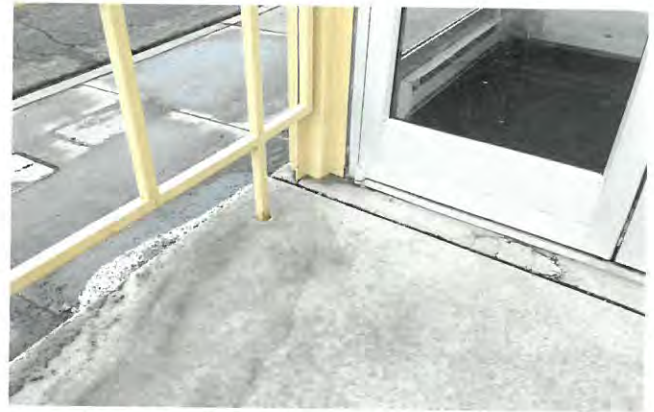
Rust at bottom of steel column and handrail post

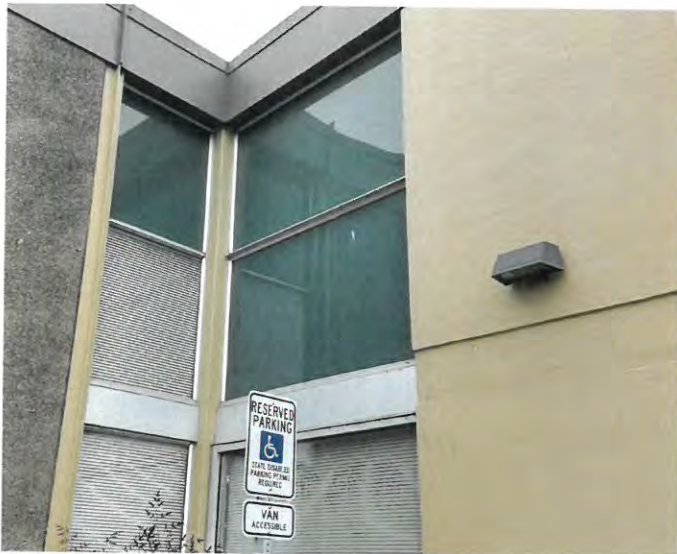
Re-entrant corner on south elevation

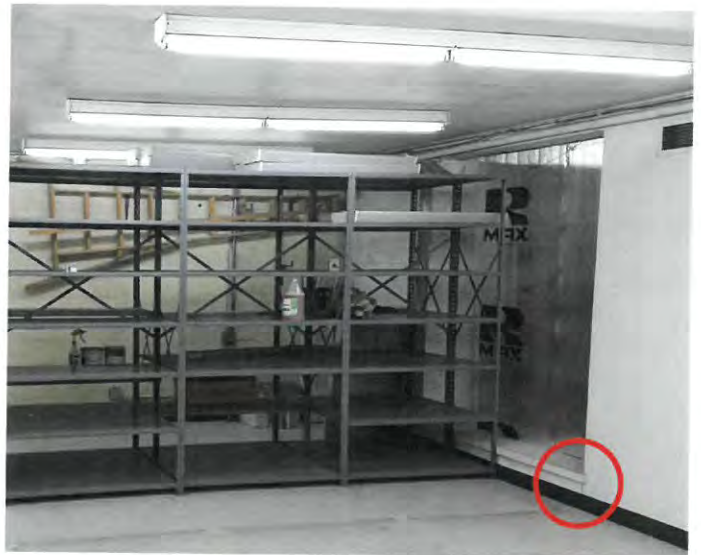
There is a crack in the wall on the second floor, in the storage room, at the re-entrant corner over the office and ATM spaces on the first floor on the north side of the exterior window. The wall surface is covered with gypsum wallboard making it unclear the make up of the wall structure. Cracks in gypsum board wall panels are not uncommon, particularly at re-entrant corners and/or where different building materials intersect, like this situation where two windows, an exposed steel column and wall framing all intersect. As such, it is probable that the crack does not represent a significant structural issue. However, it should be monitored for expansion and or moisture intrusion.

Storage room (location of crack is circled)

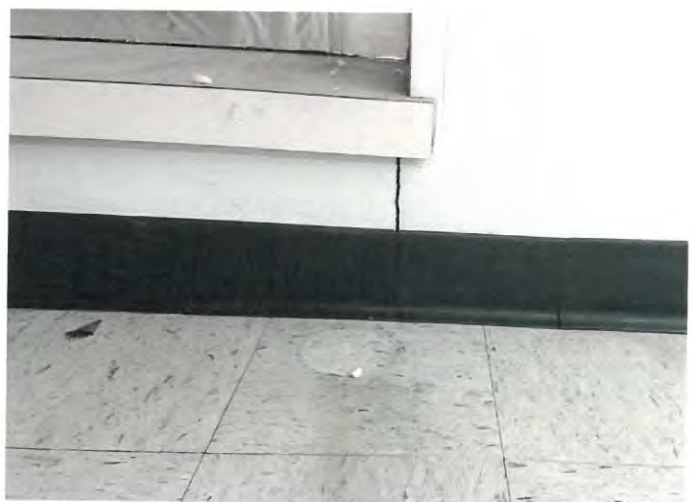
Crack

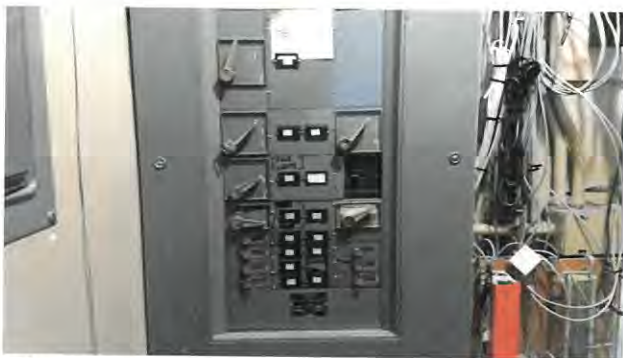
Electrical Panels

Nothing was observed that would indicate a pending issue, but due to the age of the electrical system, it is recommended that thermal imaging of the electrical panels be performed to identify; overloaded circuits, loose contacts, load imbalances, harmonic problems, etc. in the panel. The intent of this is to detect issues before they lead to significant electrical system failure and/or fire. If the results of a recently completed scan are not available it is recommended that a scan be performed as soon as reasonably possible so that any issues can be corrected and a base line established. These scans should be performed regularly as part of a preventative maintenance program. But particularly for older panels such as these.

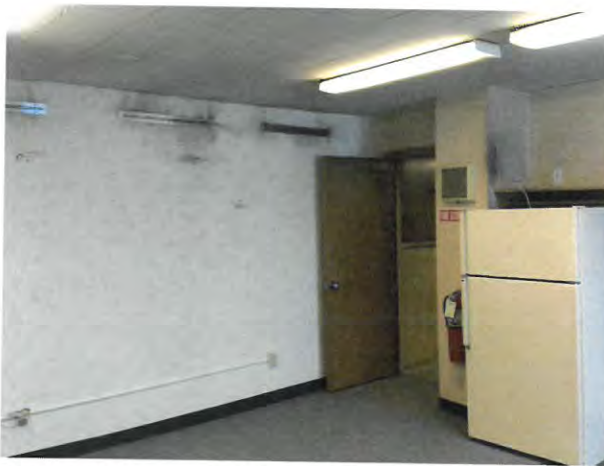
There is a black dirt/dust/residue on the walls and ceilings around many of the HVAC diffusers. It is similar to the dust/residue from a wood stove or some registers of older oil burning furnaces. The grilles and diffusers should be removed and cleaned. The ductwork should also be thoroughly cleaned and the filters should be replaced. If this does not remedy the issue it recommended that the cause of this dust/residue be further investigated and addressed.

Dust/residue around diffusers (Second floor)

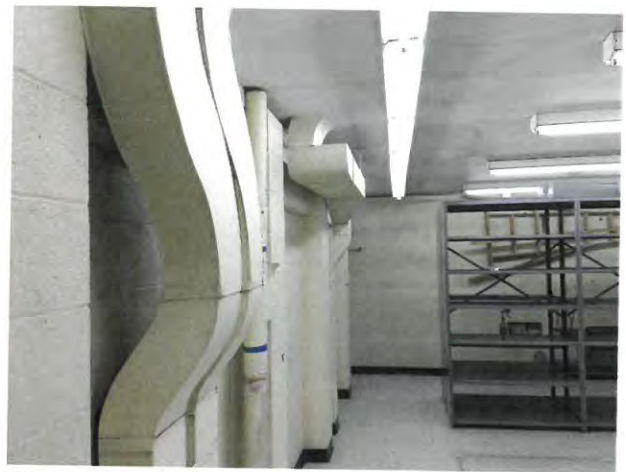
Traces of dust/residue on ceiling in Storage Room

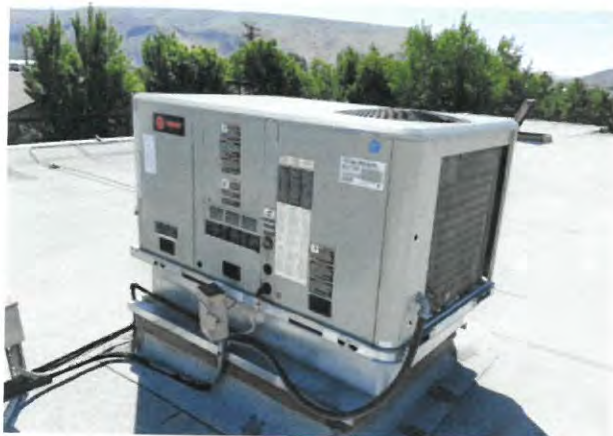
Roof top HVAC unit, gas fired (serves second floor)

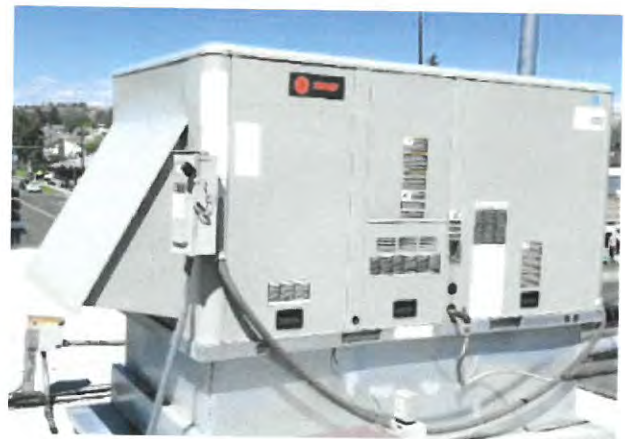
Roof top HVAC unit, gas fired (serves first floor)

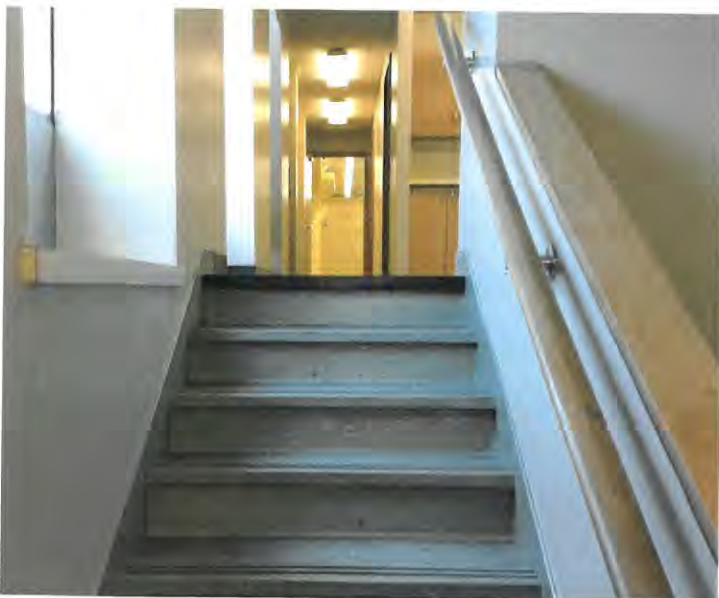
Exit signs were not observed at the top of the stairs or over either of the entry/egress doors. Lighted or photoluminescent 'Exit' signs should be installed at the top of the stairs and above each entry/egress door.

Stairs looking from landing into second floor

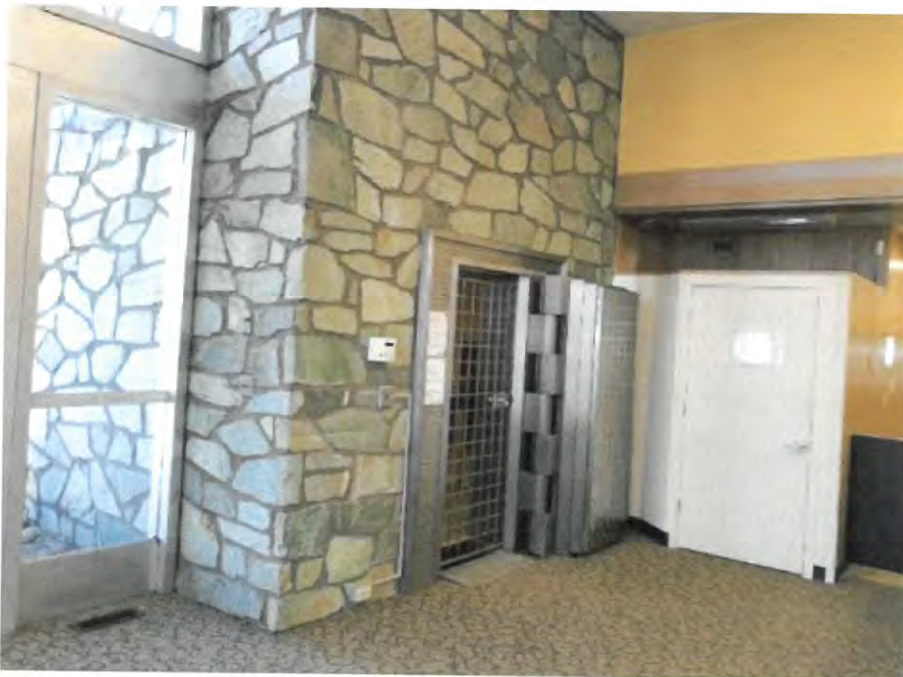
The existing vault located on the north side of the building appears to be constructed of stone clad CMU walls with furring and gypsum wallboard on the inside and carpet on the floor. Most of the space is taken up with steel safe deposit boxes. The vault is large enough to be converted to an office space, although installing windows would likely be difficult and expensive. Additional HVAC may be needed if this space is to be regularly used (such as for an office). For future tenants of the building, who do not need a highly secure storage area, the question of what to do with the large steel vault door and steel security screen door could be an issue, as they would be difficult and expensive to remove. There are also two safes (one in the vault and one under the stairs) that may not be of use to a future tenant and may need to be removed.

Vault door and gate

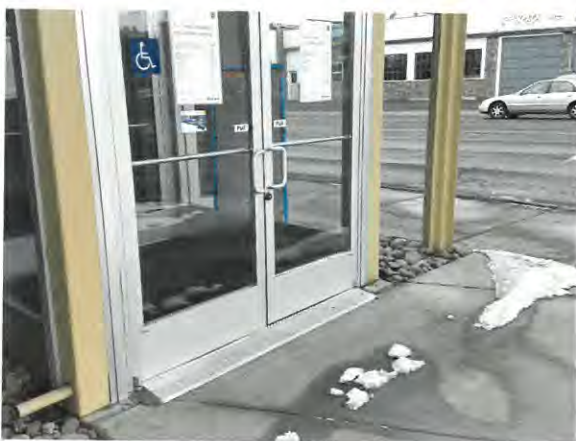
North vestibule

The existing stairs do not meet accessibility standards. See page 13 for further discussion on this issue. No elevator is currently installed. Depending on the future use/occupancy of the building and if the second floor is expanded, an elevator may or may not be required. Although some uses/occupancies require an elevator for multi-story buildings regardless of the size of the second floor.

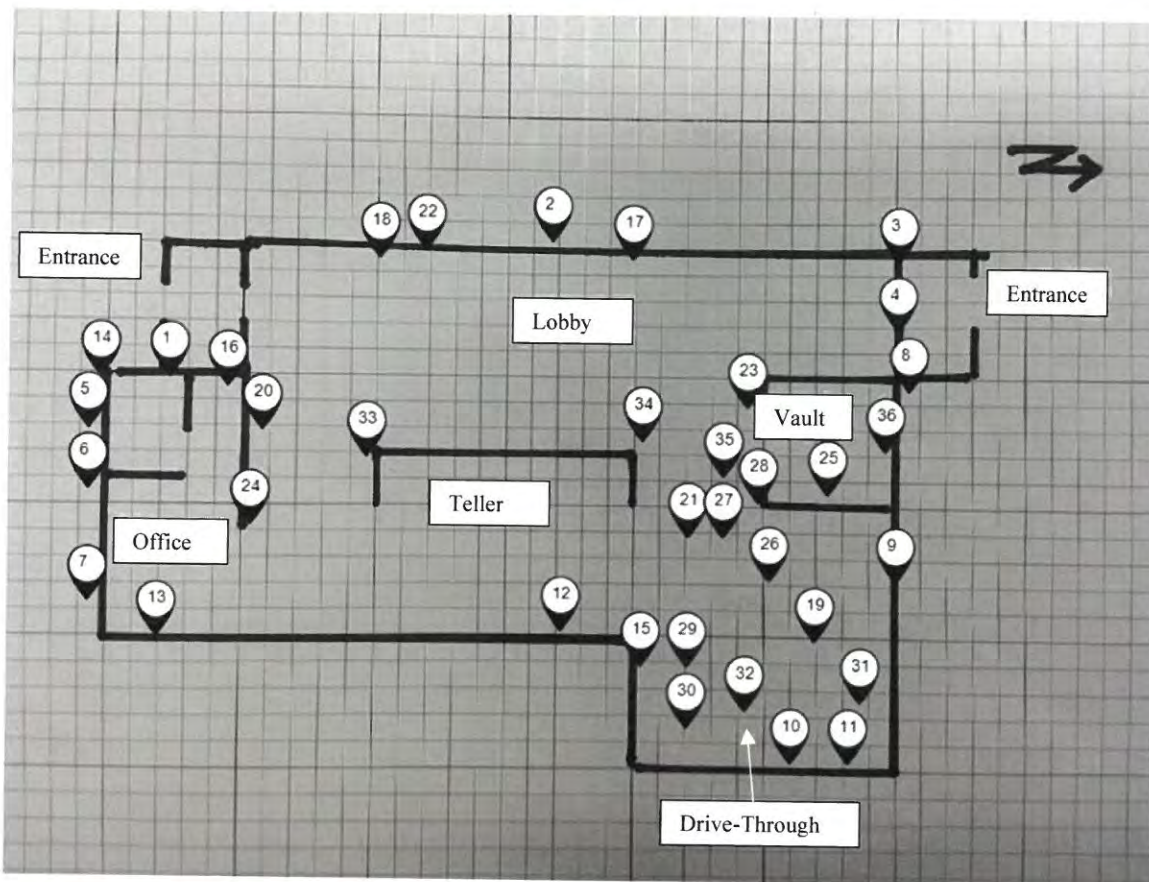
Figure 2: ACM Sample Locations – Main Floor

Map ID	Sample ID	Index	Space Name	Material
1	3819-01	GWB-01	Main floor, office closet	Skim coat finish on gypsum wallboard
1	3819-29	WP-01	Exterior, southeast entrance	White window putty Caulk, Window
2	3819-32	WG-01	Exterior, west/center window	Gray window glazing
3	3819-35	MSC-02	Exterior, northwest entrance	White putty around textured soffit
4	3819-36	MSC-02	Exterior, northwest entrance	White putty around textured soffit
4	3819-10	MSC-01	Main floor, north lobby near north entrance	Pink terrazzo floor with gray/brown spots
5	3819-38	MSC-03	Exterior, south/center wall	Purple/brown seam sealant on exterior walls
6	3819-39	MSC-03	Exterior, south/center wall	Purple/brown seam sealant on exterior walls
7	3819-40	MSC-03	Exterior, south wall	Purple/brown seam sealant on exterior walls
8	3819-69	SUR-01	Exterior, northwest entrance	Exterior stucco wall material

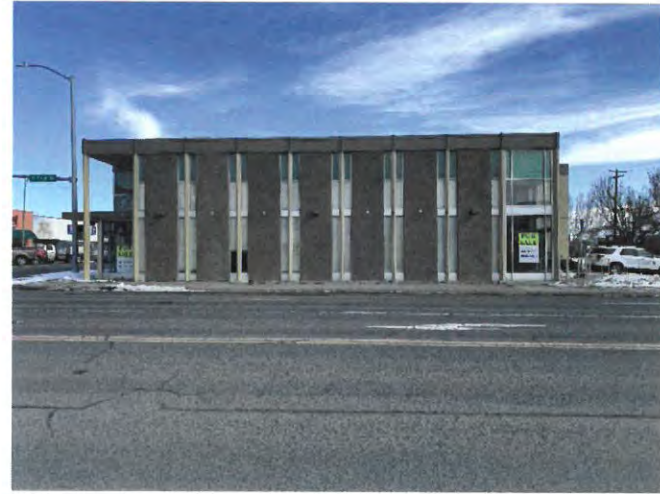
A photograph of the west exterior side of the building. The windows contain ACM window putty and glazing.

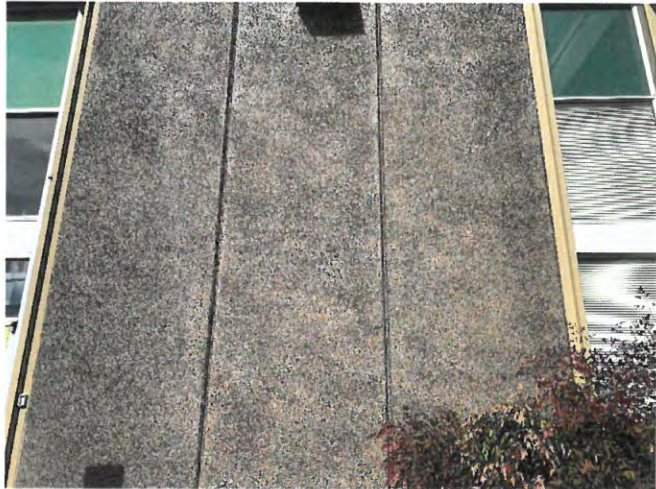
The rock wall with the ACM purple seam sealant

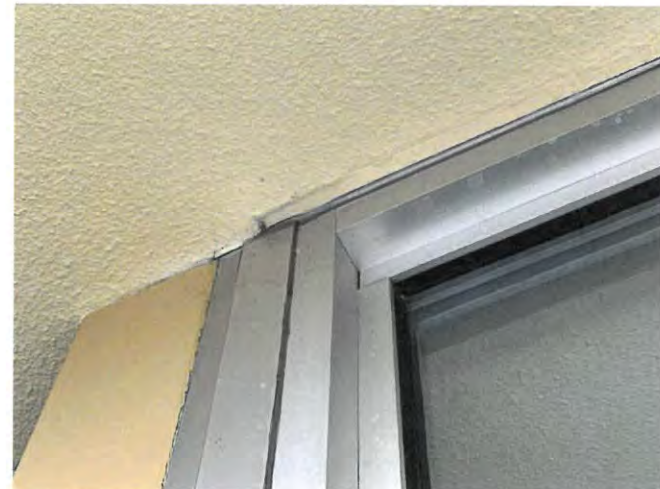
The white putty around textured soffit.

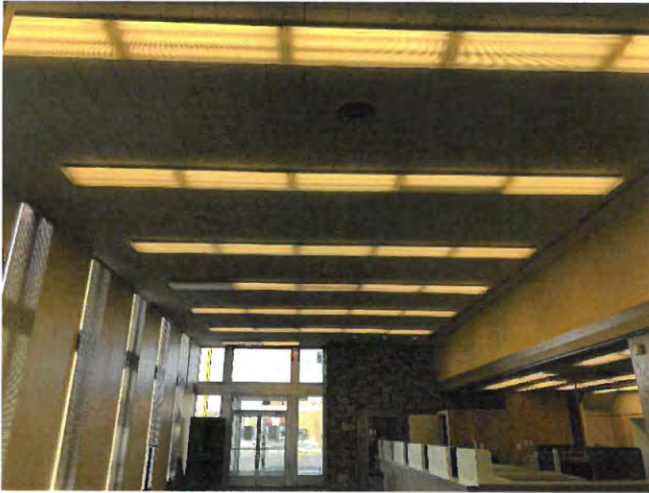
A photograph of the lobby and teller desk. The lighting and electrical systems and 12-inch ceiling tiles with brown glue dots (non-ACM).

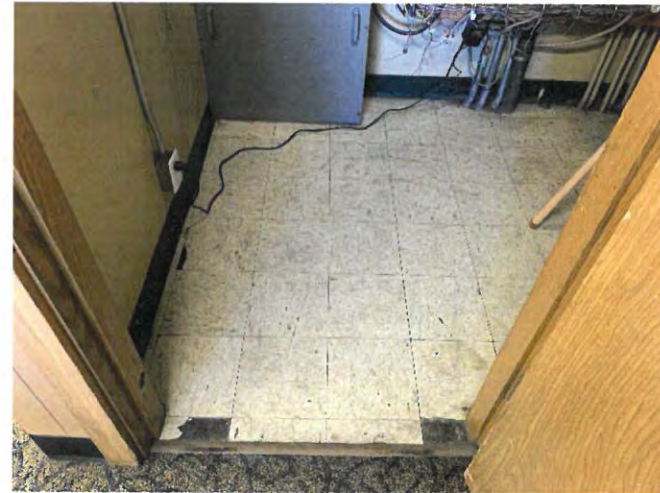
A photograph of the ACM 9-inch off-white vinyl floor tile with speck and ACM black adhesive

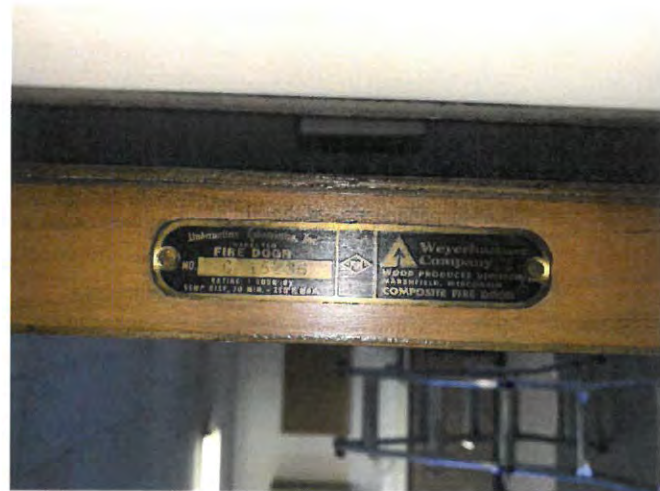
A photograph of the fire door label on the door to the mechanical room.

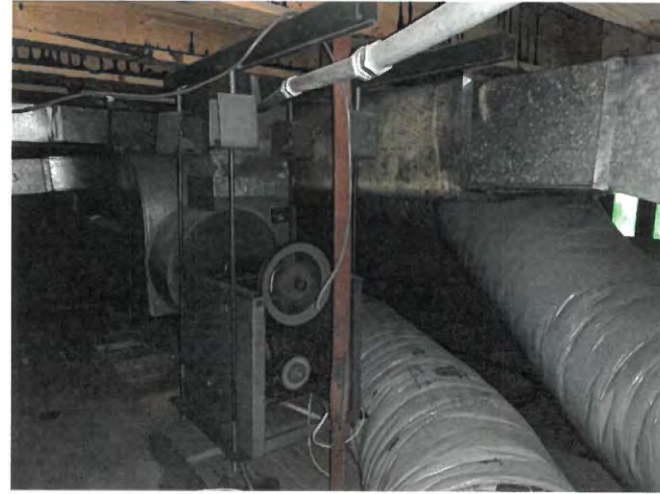
The HVAC system within the attic space.

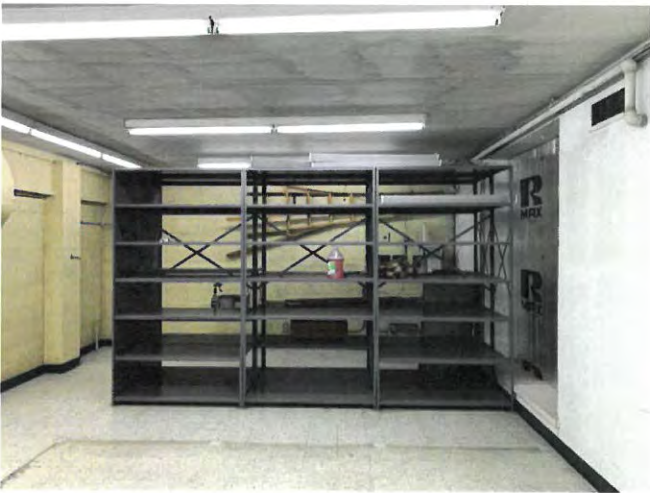
A photograph of the south second floor storage room with roof access.

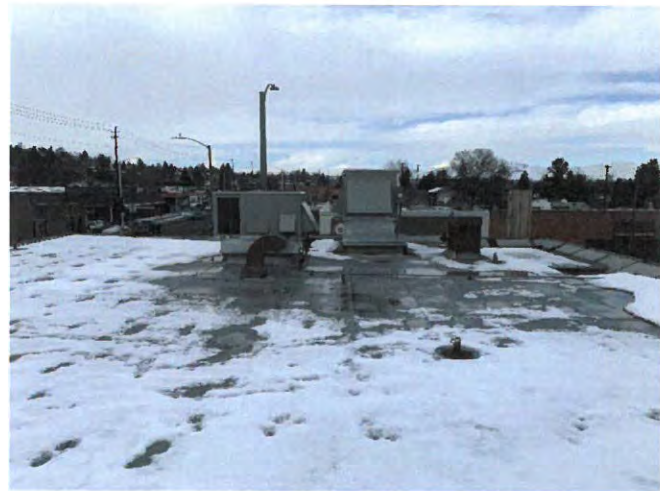
A photograph of the roof upper roof with HVAC units
